Contract #: 04-0120F4Cty: SF/ALA Rte: 80 PM: 13.2/13.9File #: 69.28**WELDING INSPECTION REPORT****Resident Engineer:**Siegenthaler, Peter**Address:** 333 Burma Road**City:** Oakland, CA 94607**Report No:** WIR-016994**Date Inspected:** 04-Sep-2010**Project Name:** SAS Superstructure**OSM Arrival Time:** 1900**Prime Contractor:** American Bridge/Fluor Enterprises, a JV**OSM Departure Time:** 700**Contractor:** Zhenhua Port Machinery Company, Ltd (ZPMC), Changxing Island **Location:** Shanghai, China**CWI Name:** See Below**CWI Present:** Yes No**Inspected CWI report:** Yes No N/A**Rod Oven in Use:** Yes No N/A**Electrode to specification:** Yes No N/A**Weld Procedures Followed:** Yes No N/A**Qualified Welders:** Yes No N/A**Verified Joint Fit-up:** Yes No N/A**Approved Drawings:** Yes No N/A**Approved WPS:** Yes No N/A**Delayed / Cancelled:** Yes No N/A**Bridge No:** 34-0006**Component:** OBG**Summary of Items Observed:**

OBG Segment Trial Assembly

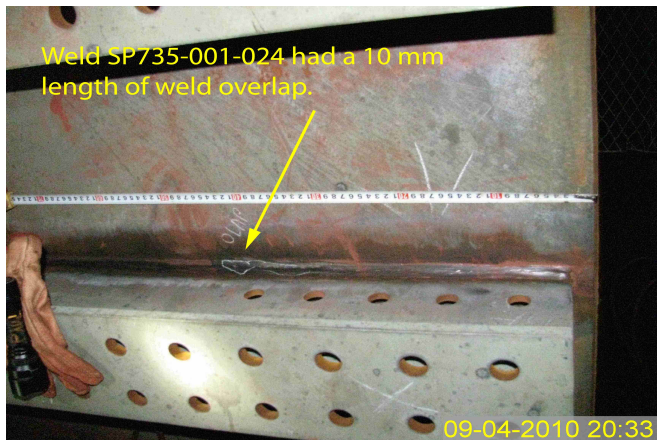
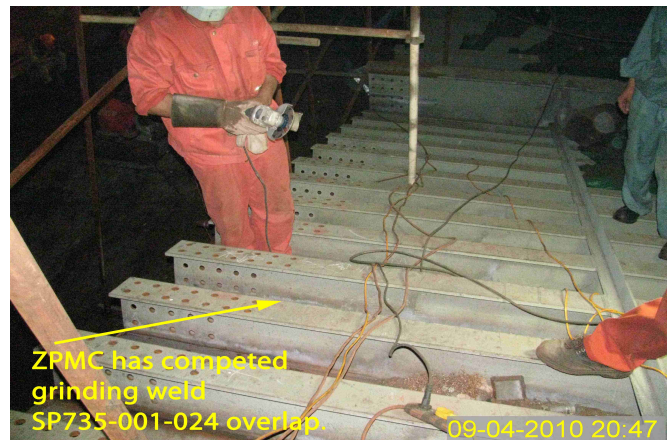
This QA Inspector observed an arc strike near one end of weld SP735-001-023 and weld SP735-001-024 had a 10 mm length near the center of the weld had overlap. This QA Inspector showed ABF CWI Mr. Kelvin Chueng and ZPMC CWI Mr. Shi Lei the arc strike and weld overlap and they had one of the ZPMC workers use a grinder to remove the arc strike and blend the weld overlap. Following completion of this grinding, items observed by this QA Inspector appeared to comply with AWS D1.5 MT and visual requirements. For additional information on

these inspections see this QA Inspector's TL6028 Magnetic Particle Test Report. Caltrans QA Inspector Mr. Mike Hasler also performed MT and visual inspections of other "T" and "I" rib hold back welds adjacent to the transverse splice weld joint on the counterweight side of OBG segment 10AW. See the photograph below for additional information.
